Aviation Safety

Ultralight and Balloon

Issue 1/2001

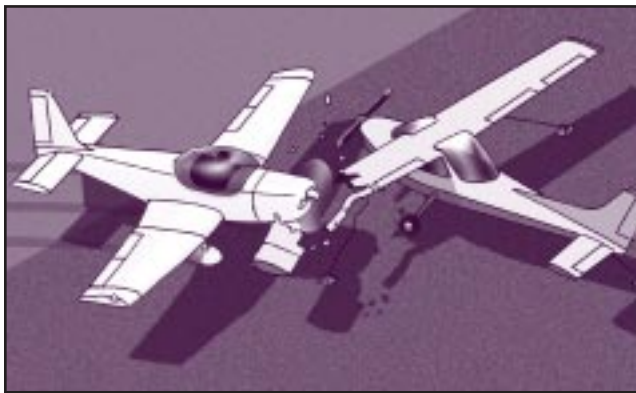
Zenair collides with Cessna 150.

The pilot of an amateur-built Zenair CH 250 was involved in a ground collision because of faulty brakes. The same type of accident resulting from

faulty brakes also occurred a few years ago at an airport in eastern Canada where substantial damage occurred to both aircraft, in that case a Piper Cherokee was involved. Therefore, history has a habit of repeating itself. Fortunately there were no injuries. In the current case, the Zenair had taxied to the runway intent on departing; however, upon entering the runway, the pilot noted that the engine RPM did not reduce when the throttle control was moved to the idle position, so he cancelled his flight plan and requested clearance back to the long-term parking area. While taxiing back to the parking area, one of the aircraft's brakes failed, and the aircraft swung off the taxiway toward a parked Cessna 150. The pilot attempted to shut down the engine using the magneto switches, but he was unable to stop the engine before his propeller contacted the other aircraft. The propeller of the Zenair chopped into the wing of the Cessna 150, severing it. The Zenair was also substantially damaged. ✈

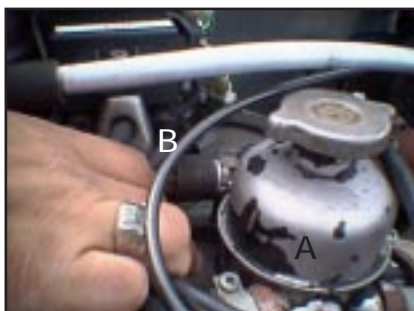
The problem was located on top of the Rotax engine where a water distributor system made out of pot metal has a line or hose to the four cylinder heads and an inlet hose where the system sits on top of the engine. This places it up against the electrical box where a stud had been wearing a hole into the water box. Once the wear line opened up a hole, the engine coolant pressure blew out antifreeze, which caused the mist in the cabin and an overheated

engine. The problem took about five years to show up. I think everyone who uses this engine should check to see if this bolt has rubbed a hole into this water distribution system on his/her unit. This may save an engine failure or accident. The inspection method and only way to see this problem is to push over the tank by hand so you can see the problem stud.

Photo of similar system indicates location of the problem. Note: To avoid this problem, the water distributor (A) should be positioned on a rubber base pad and located to avoid any contact with other components, such as the electrical box (B).

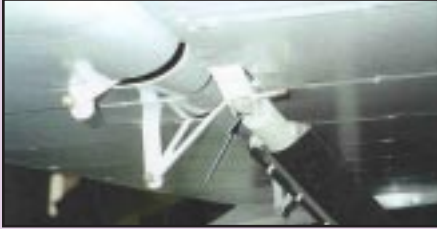
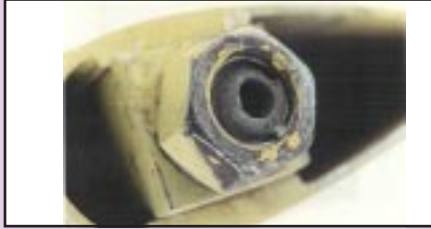
The TSB Lab examined a broken fitting that secured the wing strut to the aircraft and determined that the failure of a wing attachment strut fitting was due to overload, probably as a result of the aircraft striking the ground in a stalled condition. ✈️

Close up of the fracture surfaces from the right strut of the accident aircraft.

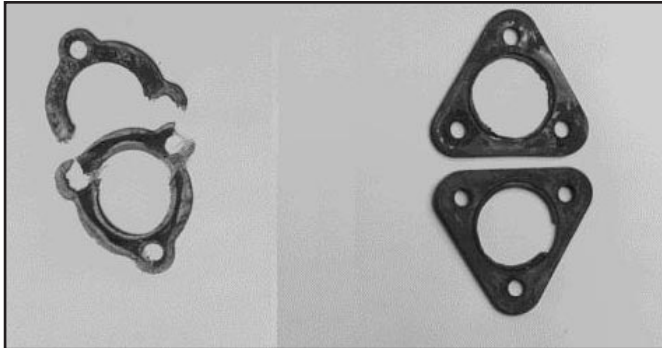
Exhaust gasket (left) and flange (right) as removed from the burned helicopter engine. The flange illustrates to some extent the properties of the weld that the owner felt were of poor workmanship.

Exhaust gasket failures were reported by several Rotorway Exec owners to be the cause of a number of in-flight problems. In one Canadian case, the owner reported that a leaking exhaust gasket coupled with a poorly welded flange caused an in-flight fire that resulted in a forced landing; the machine was consumed by the fire. This helicopter was equipped with an after-market turbocharger. Although the manufacturer does not support this installation,

according to the owner it was not the problem. In a second case, the Canadian owner reported that a failed exhaust gasket resulted in an autorotation (emergency landing) because the escaping hot gases burned a coolant line, resulting in engine failure.
